NAVAL FACILITIES ENGINEERING SERVICE CENTER
Port Hueneme, California 93043-4328

Technical Report TR-2040-OCN

FDS-D WET-END SURVIVABILITY POST TEST ANALYSIS

March 1995

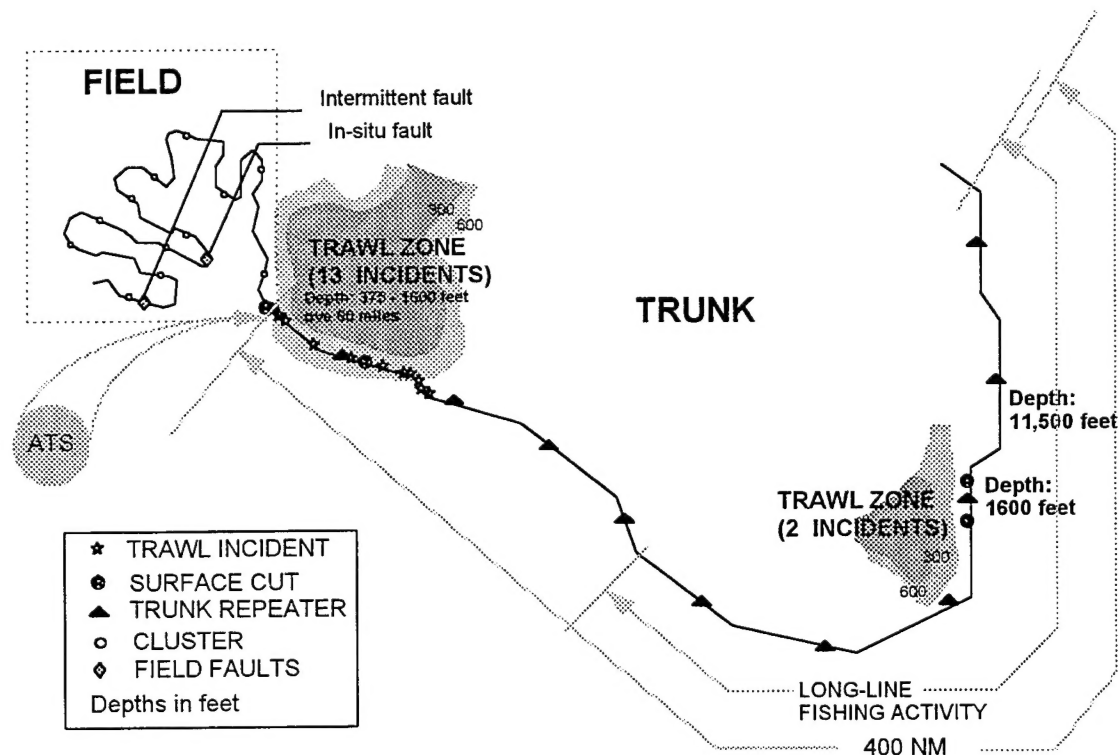
FIGURE 1. FDS-D UWS IN-SITU FAULTS

Figure 1 identifies the locations of the in-situ faults.

2.2.1 Trawling Faults. Trawling activity was the leading cause of failure in the FDS-D UWS. While the UWS was exposed to the many threats in the

ocean environment, only trawling damage was a significant survivability problem. A total of 15 out of 17 in-situ faults were caused by trawling. All 15 trawling faults were in the trunk. Trawling damage was isolated to two heavily trawled areas covering 62 nautical miles out of 500 nautical miles along the UWS (12% of the total length). Trawl damage occurred in depths ranging from 380 to 1800 feet. Both areas were adjacent to shallow water banks. If the cable had been routed only a few miles over to one side of the existing route, the cable would have been in much deeper water and the trawling threat may have been avoided. Two reasons have been given for not routing the trunk in the adjacent deep water:

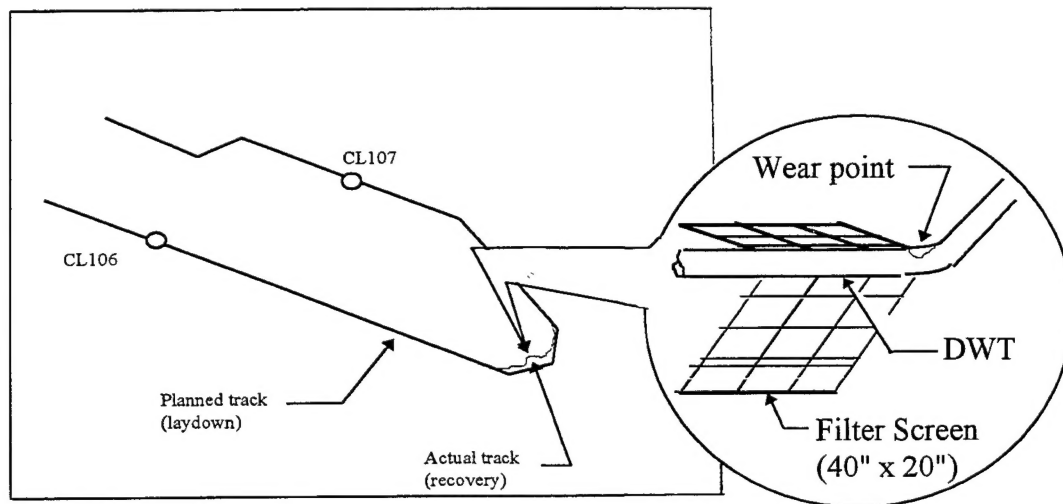
FIGURE 2. FAULT BETWEEN CL106 AND CL107

2.2.2 Cut and/or Abrasion Compounded with Corrosion and Cold Flow. One failure occurred in the field that was not trawling related -- the cable became entangled with a steel wire filter screen on the seafloor between CL106 and CL107. The failure appears to have been caused by an initial cut in the cable jacket from the filter screen, compounded with corrosion and cold flow. The failure resulted after a prolonged period of operation (81 days). The entanglement may have been initiated during installation. The evidence points to the cable being pulled through a turn during installation while the deployment ship was making a sharp course change. High surface current velocities of up to two knots were recorded near the fault position, which may be a contributing factor. No damage was observed on either side of the fault point, and no evidence supports that the cable was dragged at this point after deployment. Although site specific factors may be involved, **the scenario suggests that this failure mechanism could be a problem in future FDS deployments.**

No evidence was found to link this fault to trawling. The failure occurred in the middle of a 160-degree turn in the laydown track. The filter screen was bent or doubled over at a hard angle around the cable and a wear point developed where it made contact with the cable. The configuration of the filter screen on the cable and the cable location during recovery led to the hypothesis that the cable was inadvertently pulled through the turn during deployment. Hence, this fault is theorized to have been caused by a combination of the following:

- Excessive tension in the cable.
- In situ hazard that resulted in a cut or abrasion to the jacket.
- Corrosion of the steel shield.
- Cold-flow of the dielectric and electrical failure of the cable.

Figure 2 illustrates this problem.

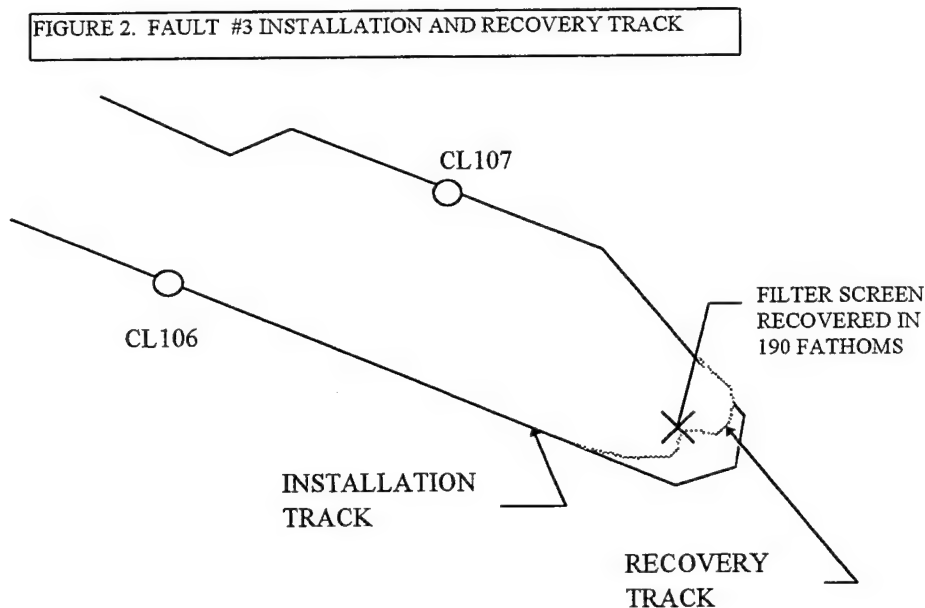
One unique failure occurred in the field that was not trawling related -- a steel wire filter screen became wrapped around the cable on the seafloor. The entanglement presumably began during deployment. The failure appears to have been caused by an initial cut against the filter screen, compounded with corrosion and cold flow. The failure resulted after prolonged period of operation (81 days). The evidence points to the cable being over-tensioned during installation while the deployment ship was making a sharp course change. No damage was observed on either side of the fault point, and no evidence supports that the cable was dragged at this point after deployment. Although site specific factors may be involved, the scenario suggests that this failure mechanism could be a problem in future FDS deployments.

The failure was located between CL106 and CL107. The cause of the failure was discovered during the recovery when a steel wire filter screen was brought to the surface wrapped around the cable. The filter screen looked like it came from an air vent on a shipwreck or from a dump site. The filter screen was wrapped at a hard angle around the cable, indicating the cable was under tension while in contact with the filter screen on the seafloor. The cable jacket and dielectric had cold-flowed around the filter screen wire where it made contact with the cable. The failure occurred in the middle of a 160-degree turn in the field laydown track, which supports the theory that the cable was over-tensioned and pulled through the turn until it hooked onto the filter screen. Figure A-2 provides a drawing of the laydown and recovery track.

During recovery, no damage was observed on either side of the fault point, and no evidence was found that the cable had been hit or dragged by trawl gear after the cable reached its in-situ location. The lack of evidence of external forces causing the damage, such as trawling, leads to the hypothesis that the cable fault was the result of an in-situ hazard condition combined with a cable design vulnerability. This scenario could also be further complicated by too little slack control at the deployment ship during installation. This cable fault is theorized to have been caused by a combination of cut and abrasion to the jacket, corrosion of the steel shield, cold-flow of the dielectric, and electrical failure. Although this would be the first known failure to have occurred this way, corrosion evidence gathered from autopsy samples support that a major vulnerability of FDS DWT may exist for this mechanism

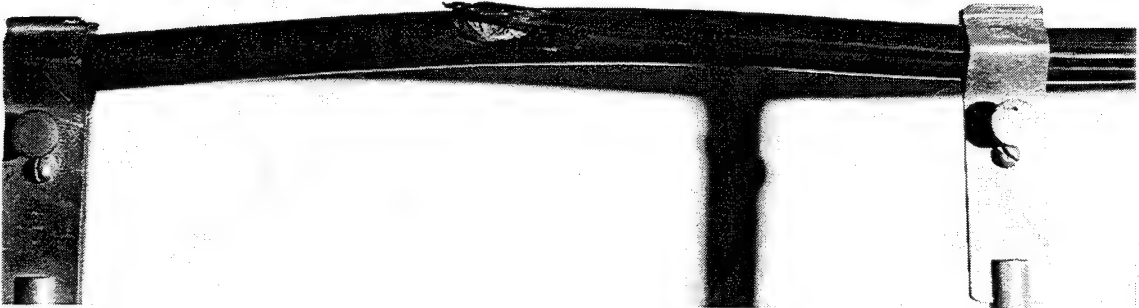
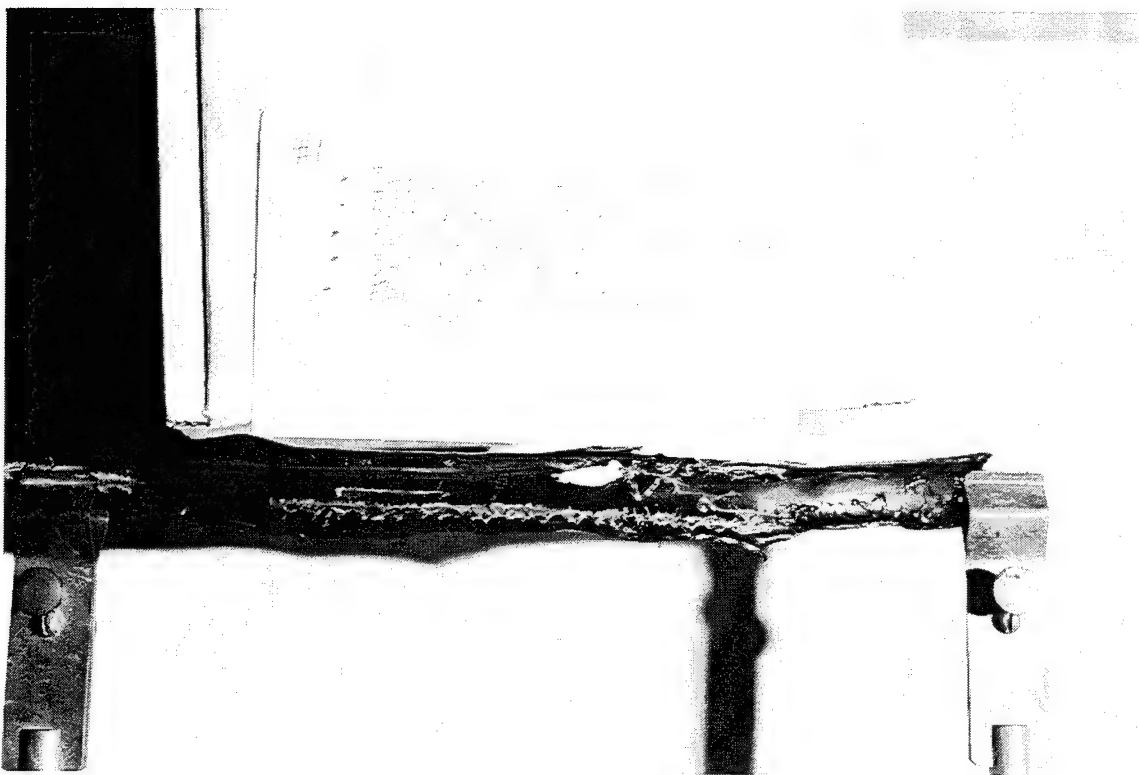
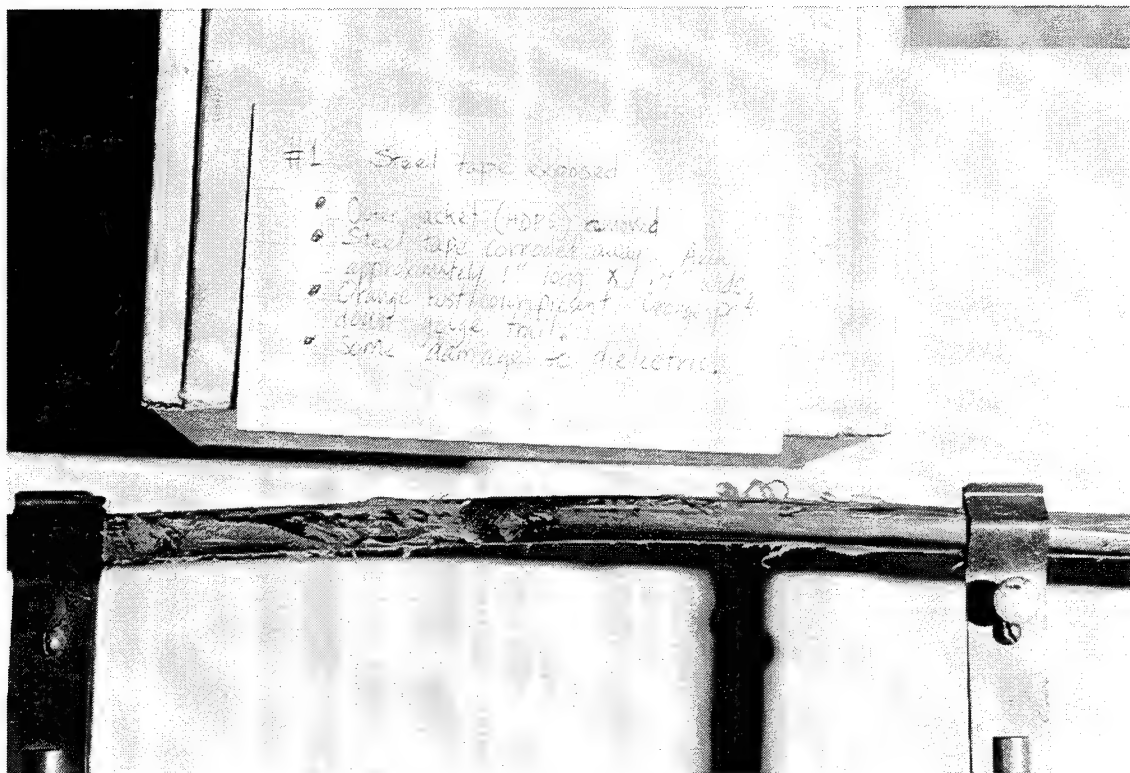
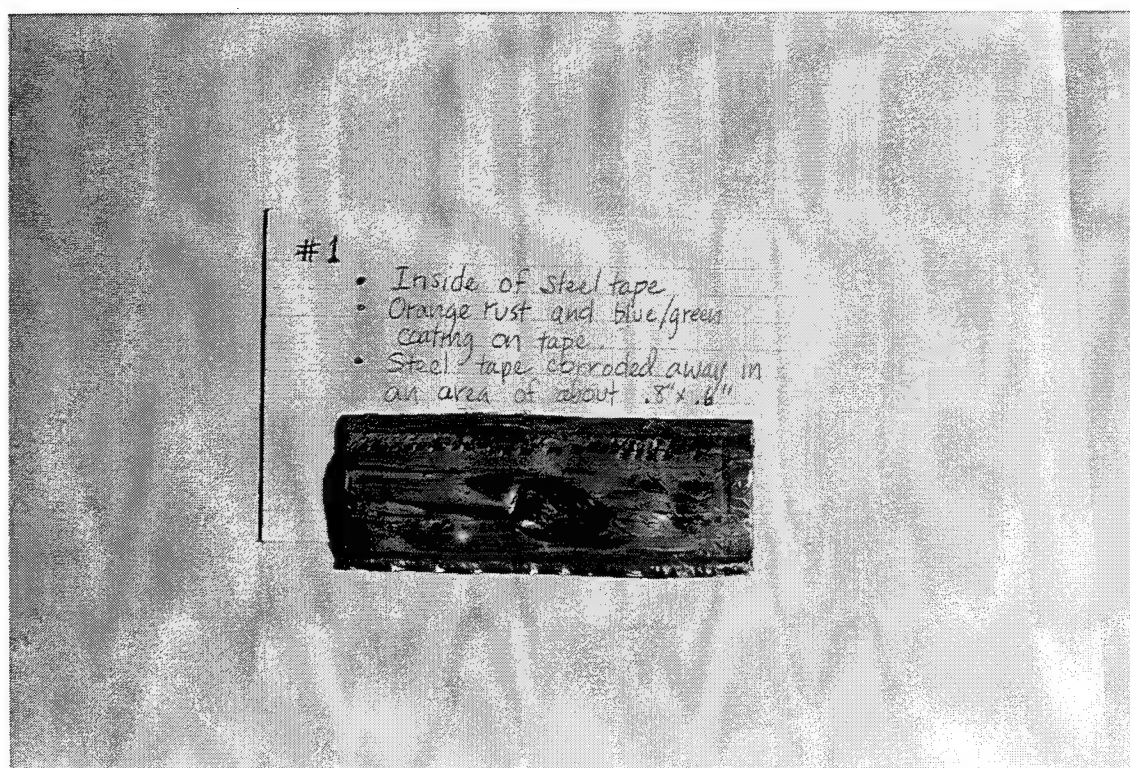
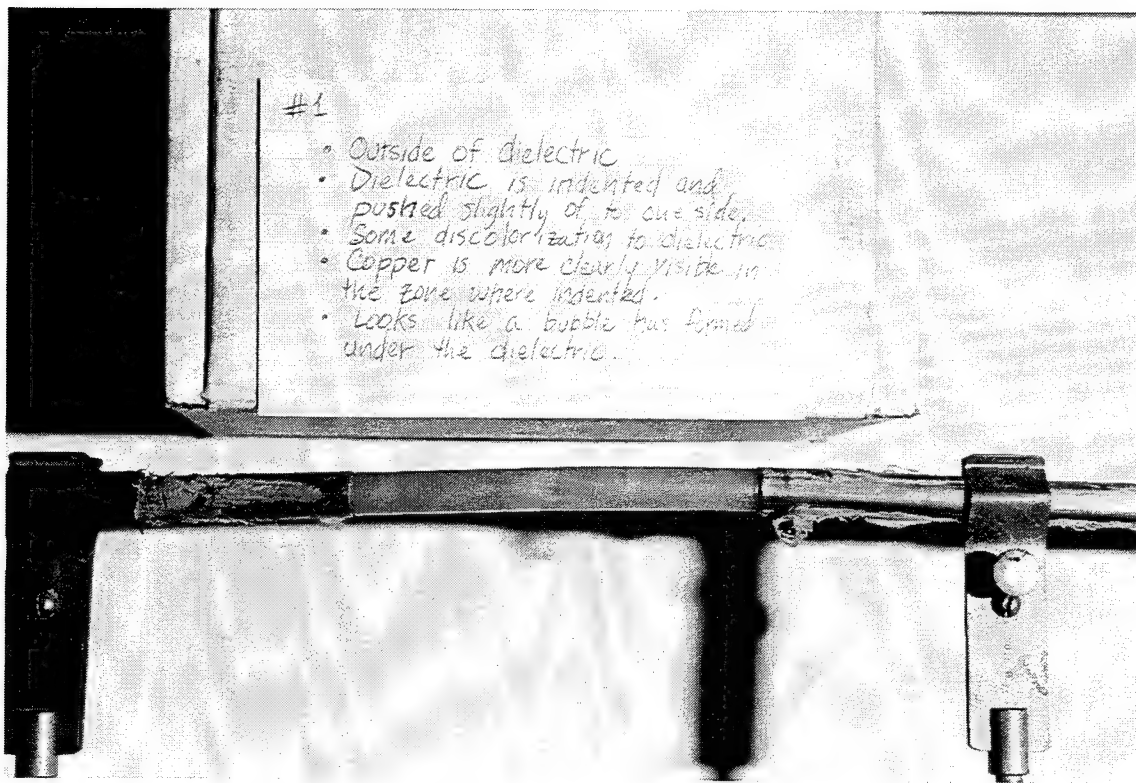
Condition of Optical Fiber Sheath: Not inspected.

Condition of Fiber: Not inspected.

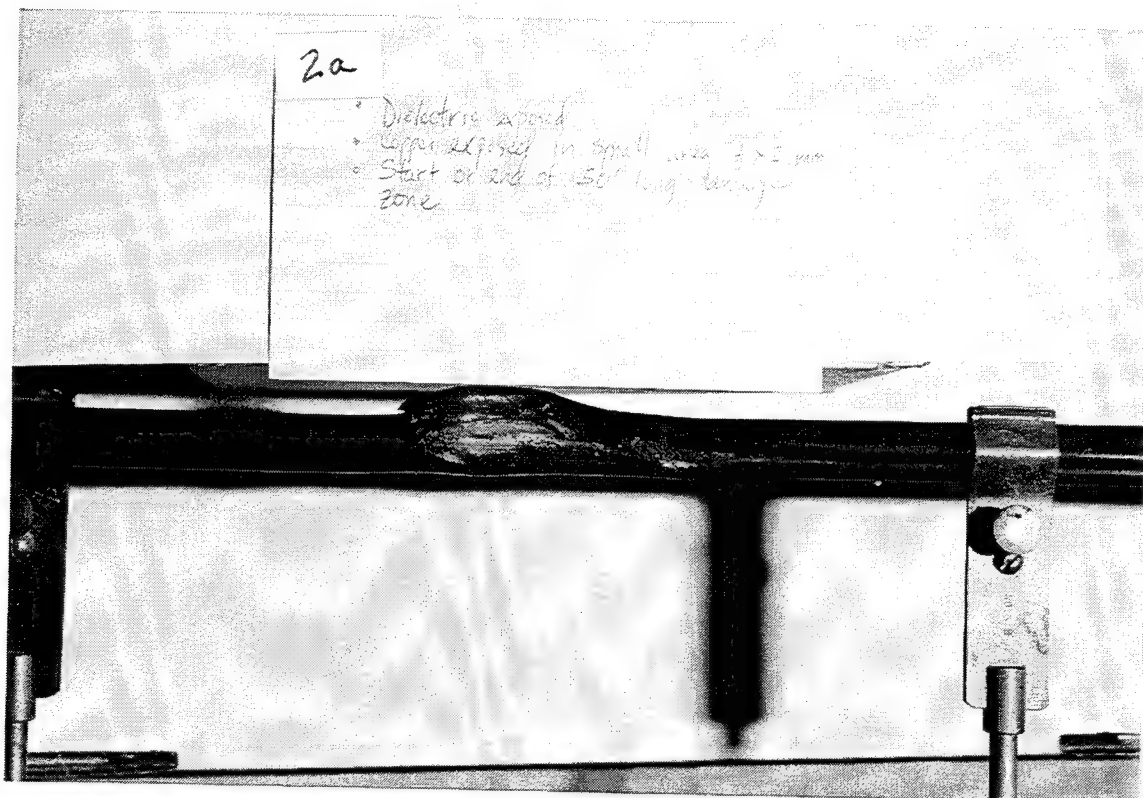
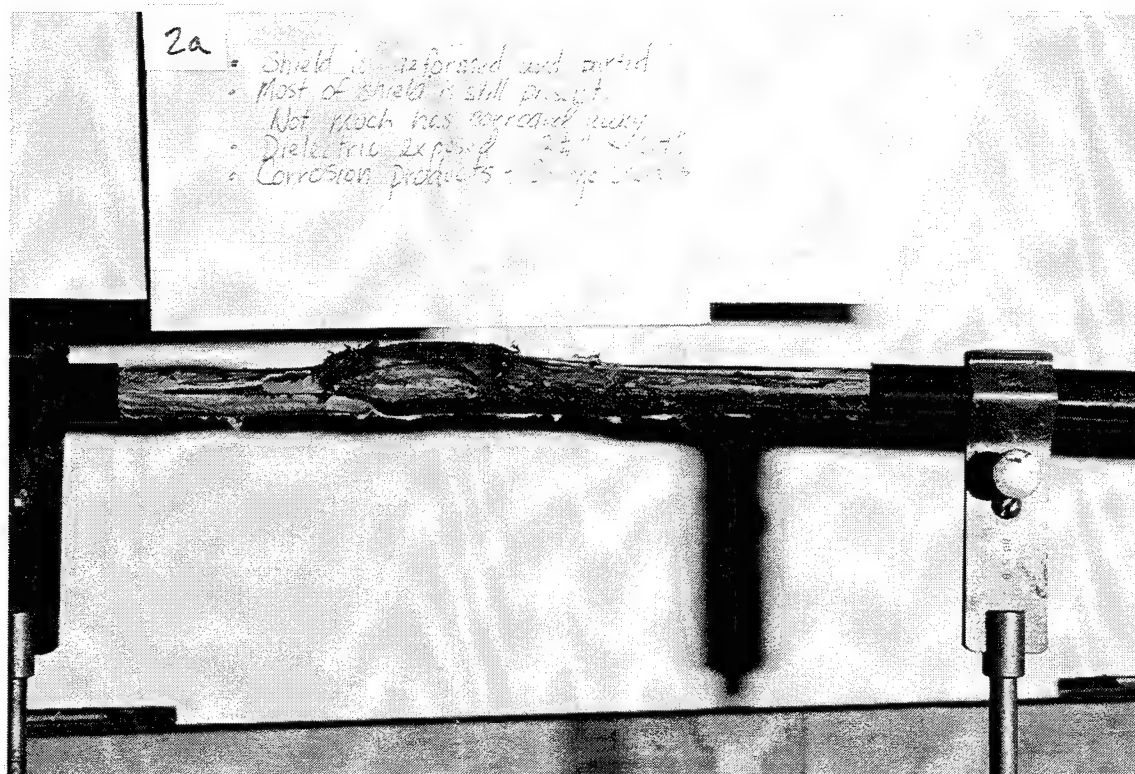
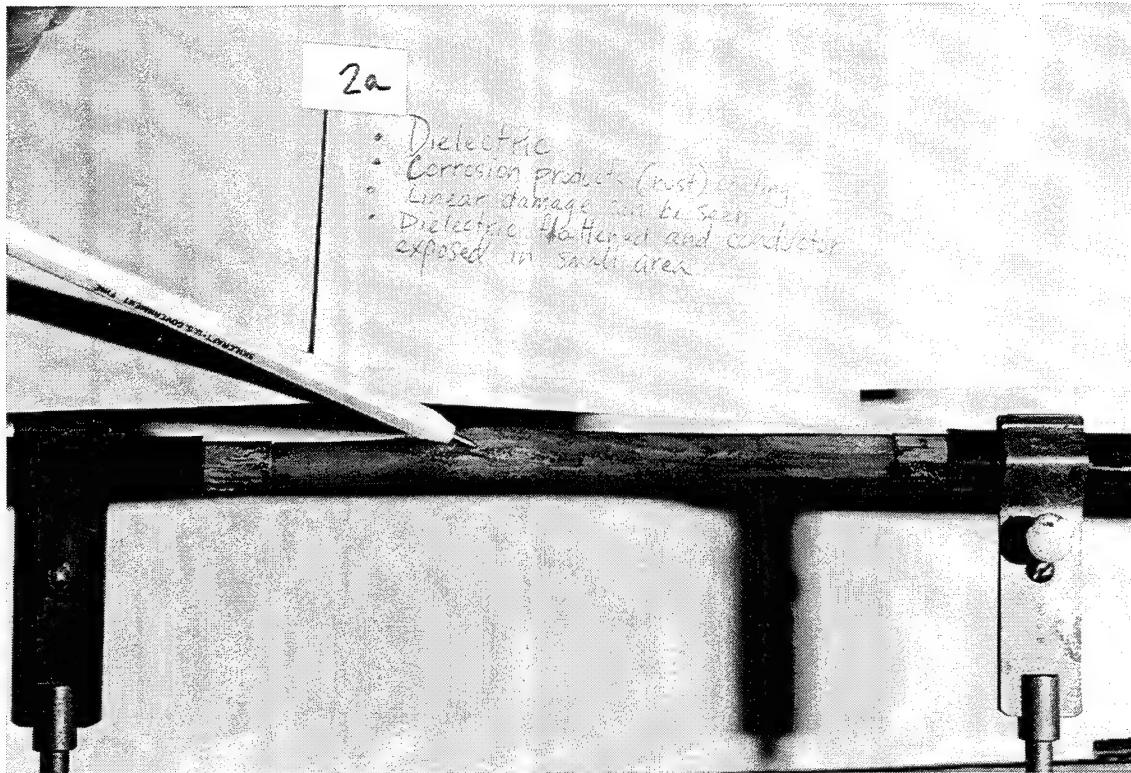
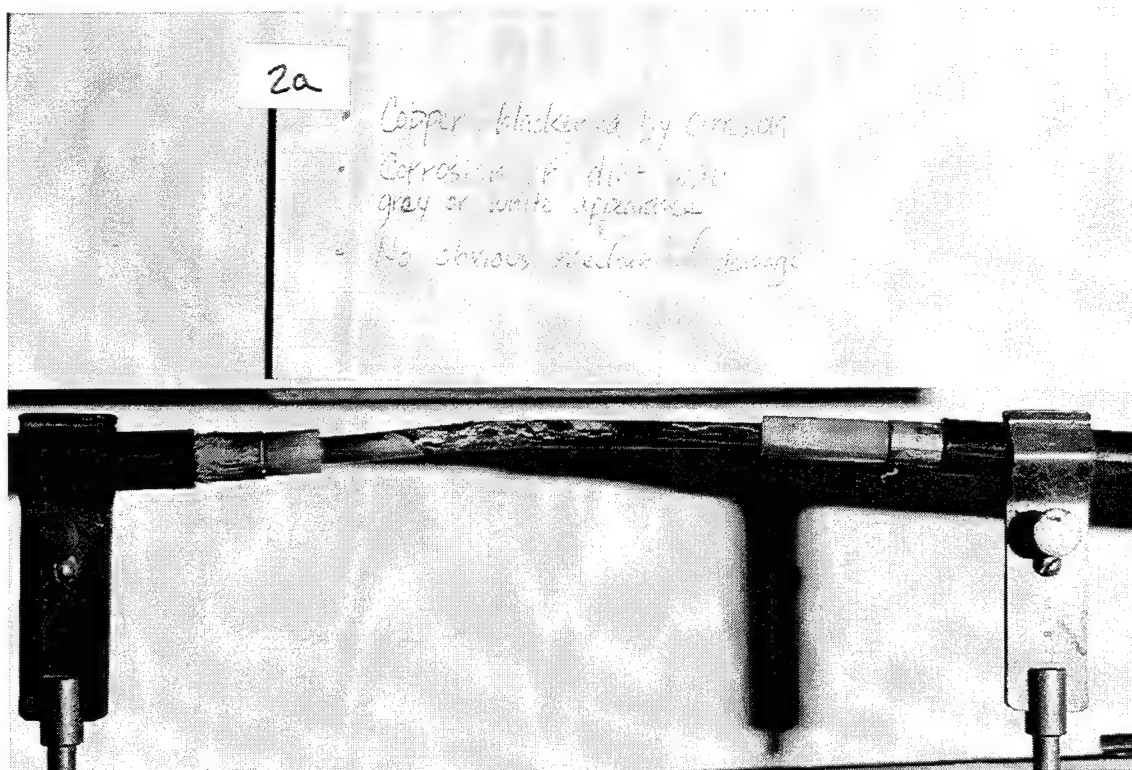
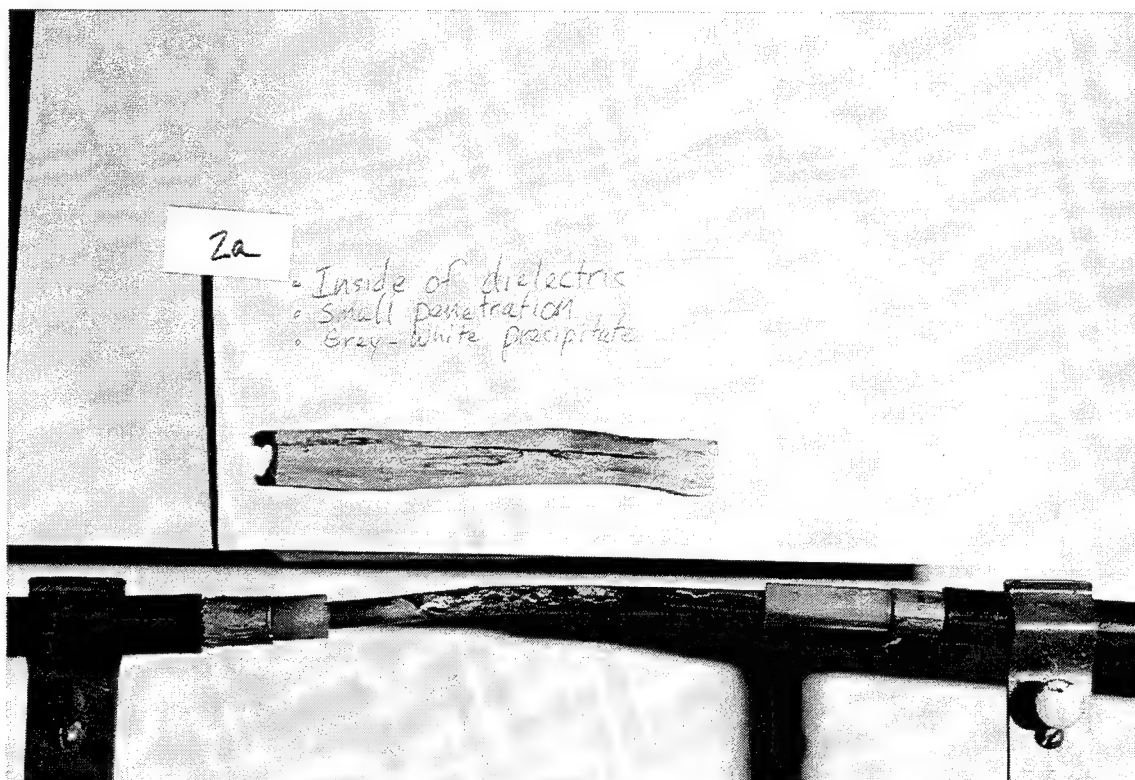
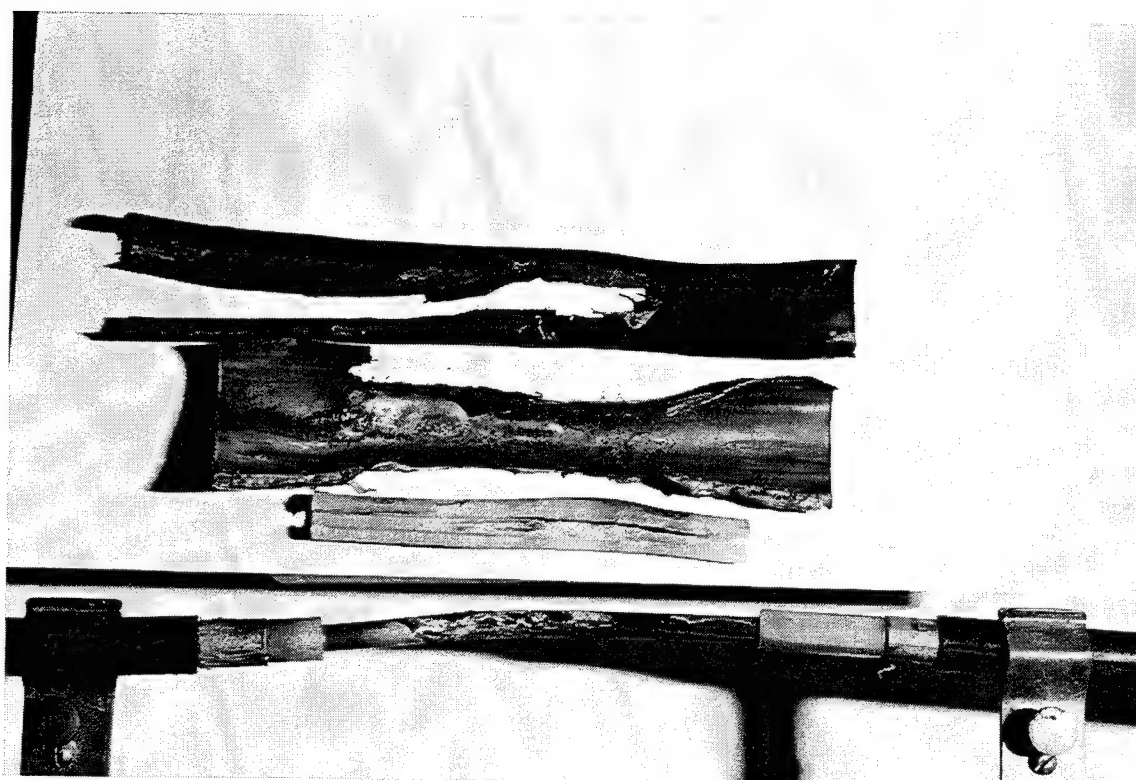
5.2 Fault Number 2a - FDS-D CABLE AUTOPSY WORKSHEET

Condition of Optical Fiber Sheath: Not inspected.

Condition of Fiber: Not inspected.

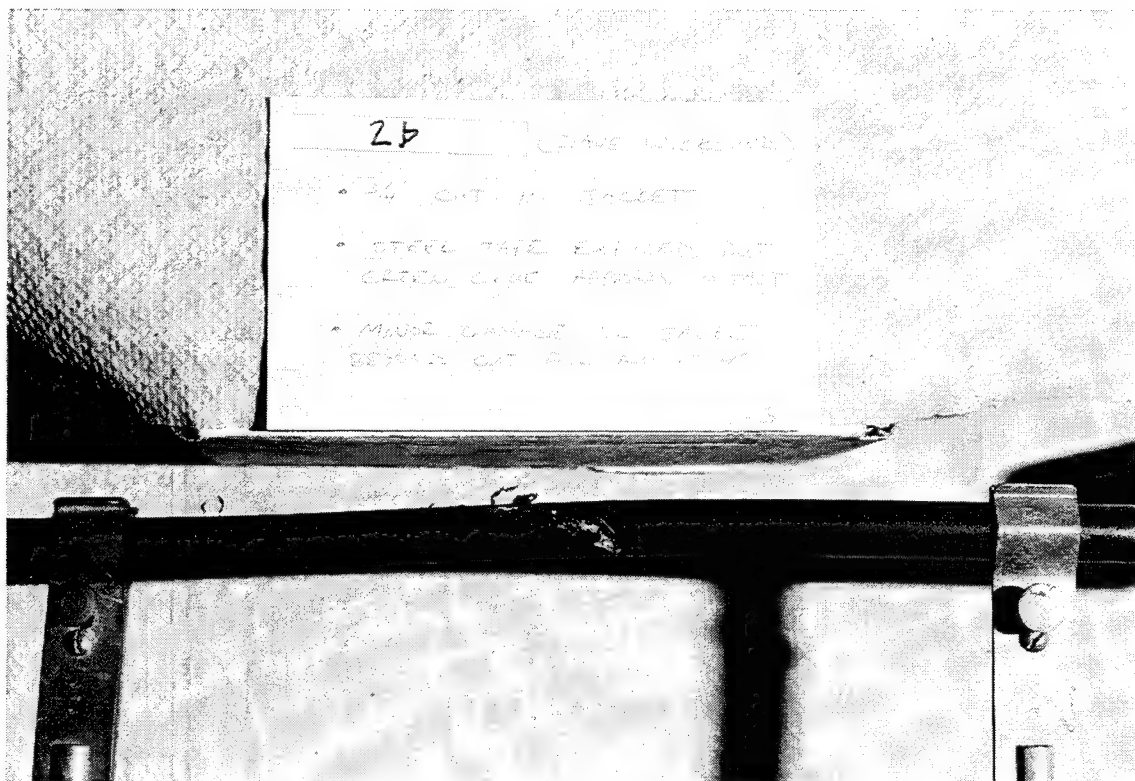
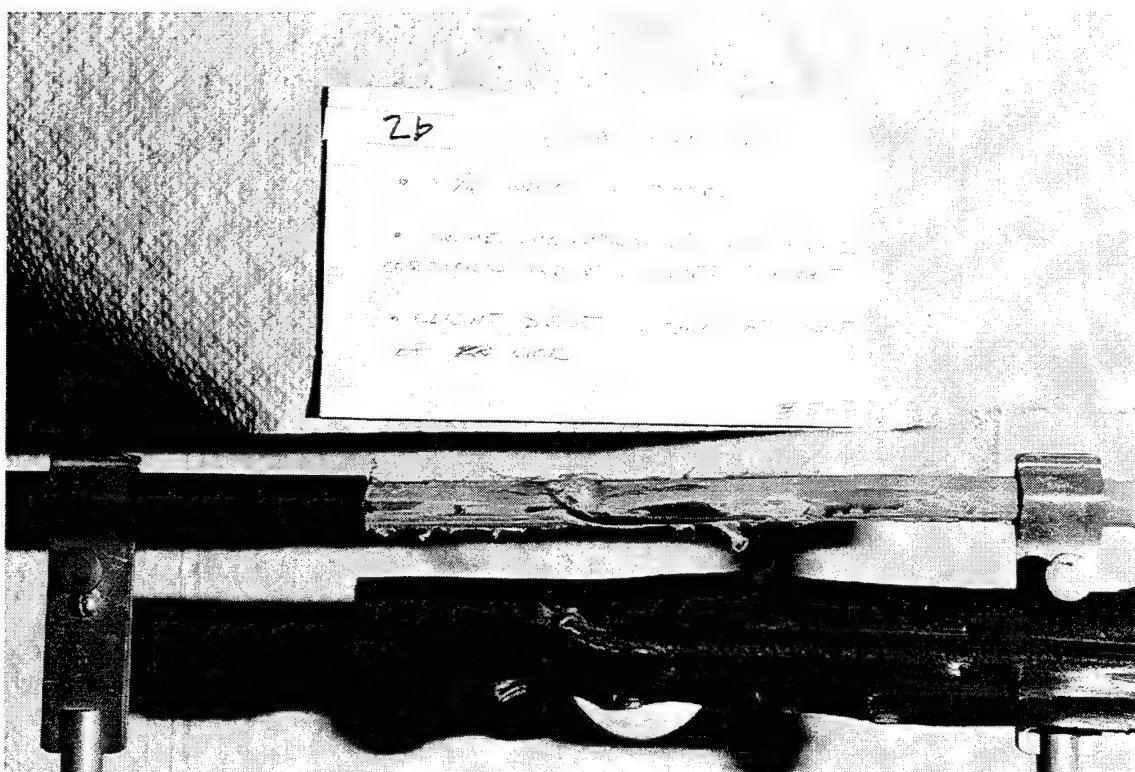
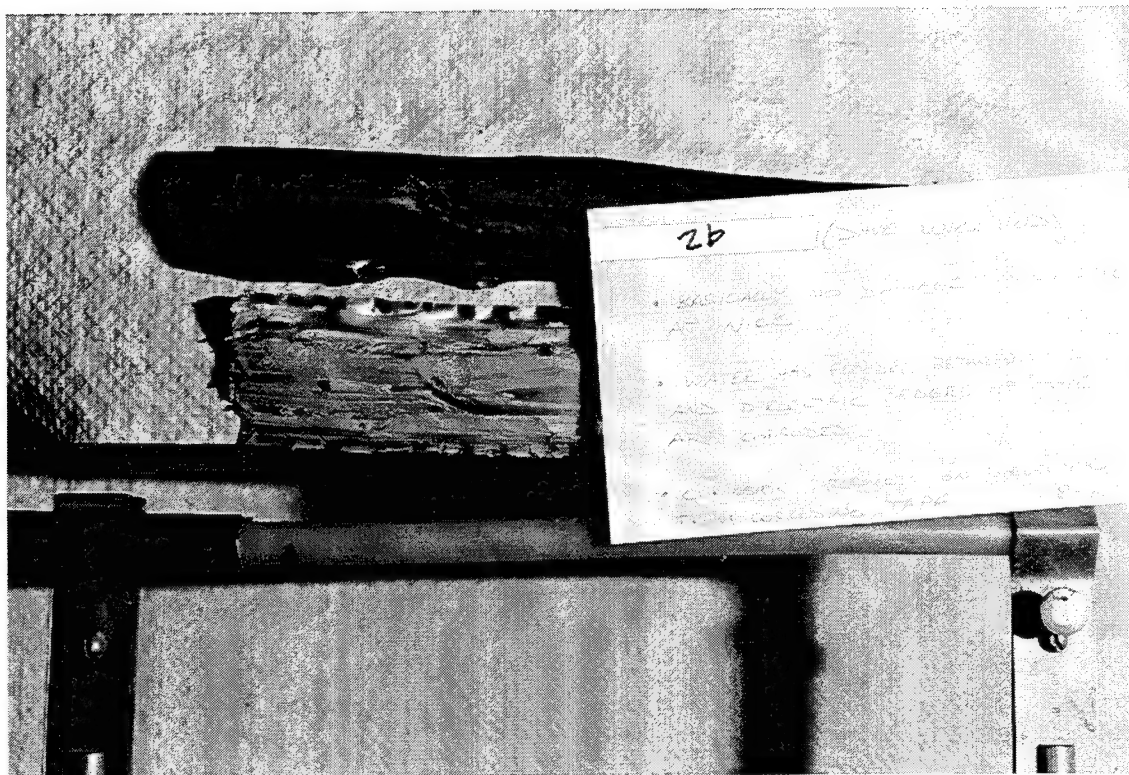
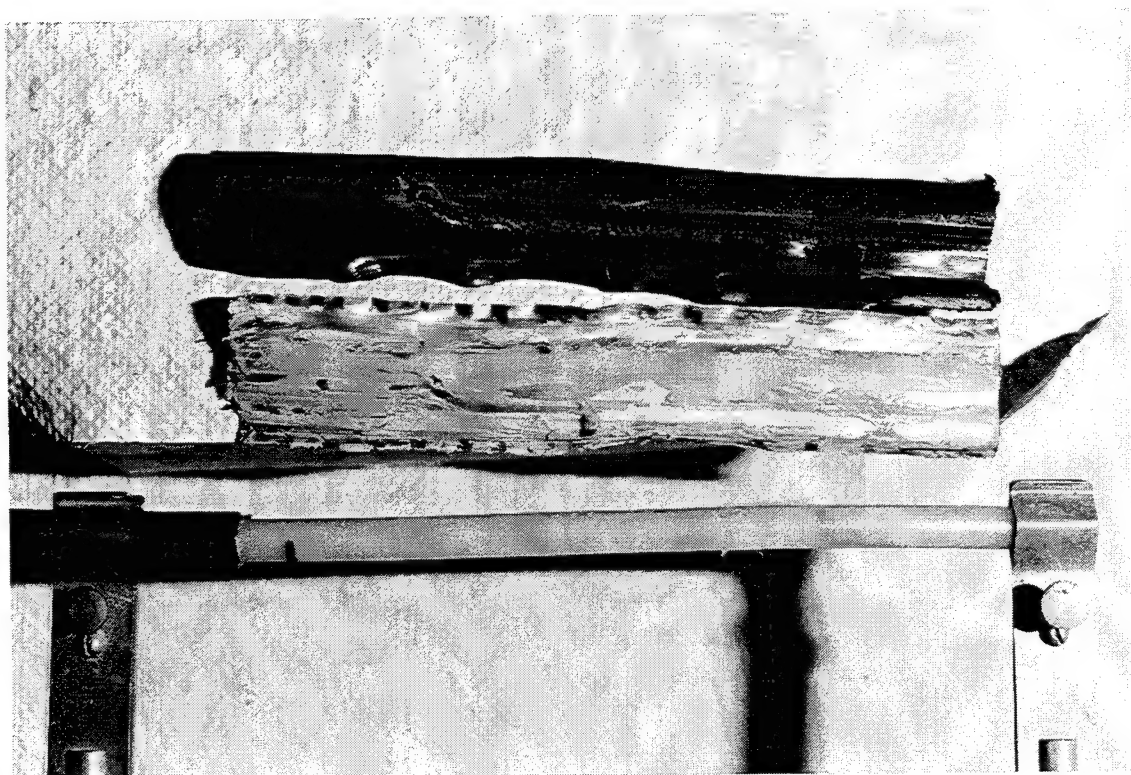
5.3 Fault Number 2b - FDS-D CABLE AUTOPSY WORKSHEET

Condition of Optical Fiber Sheath: Not inspected.

Condition of Fiber: Not inspected.

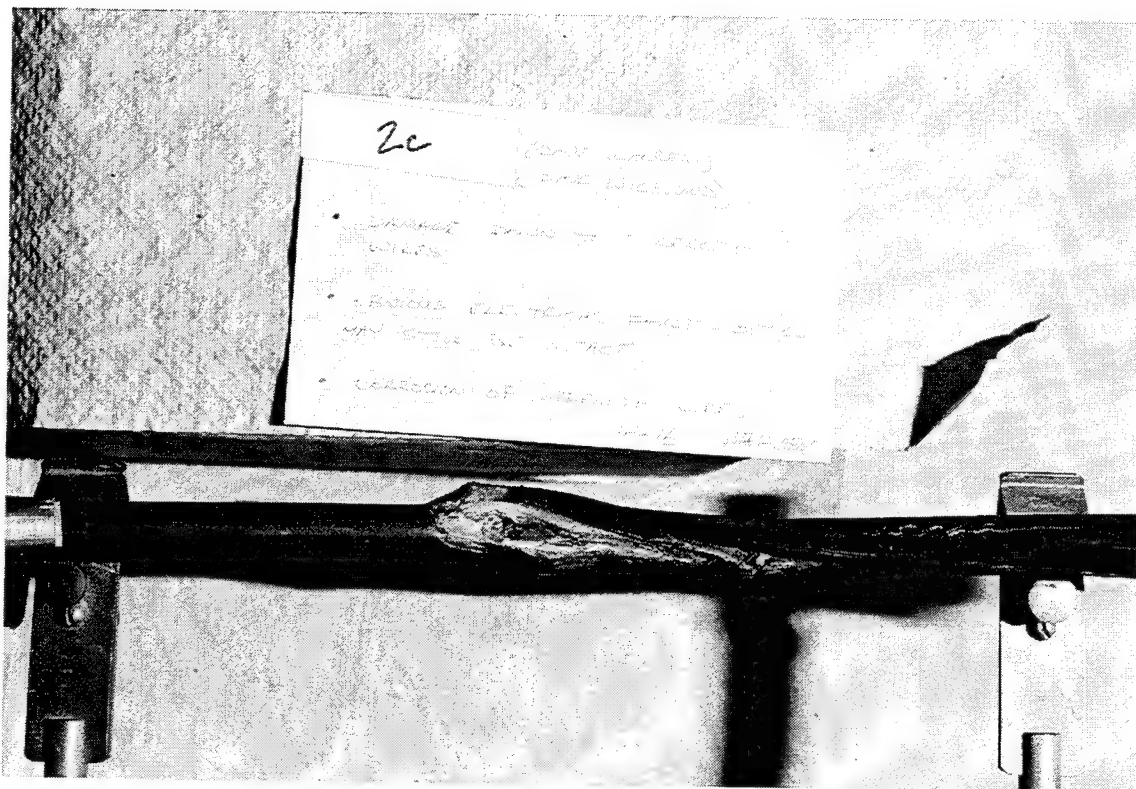
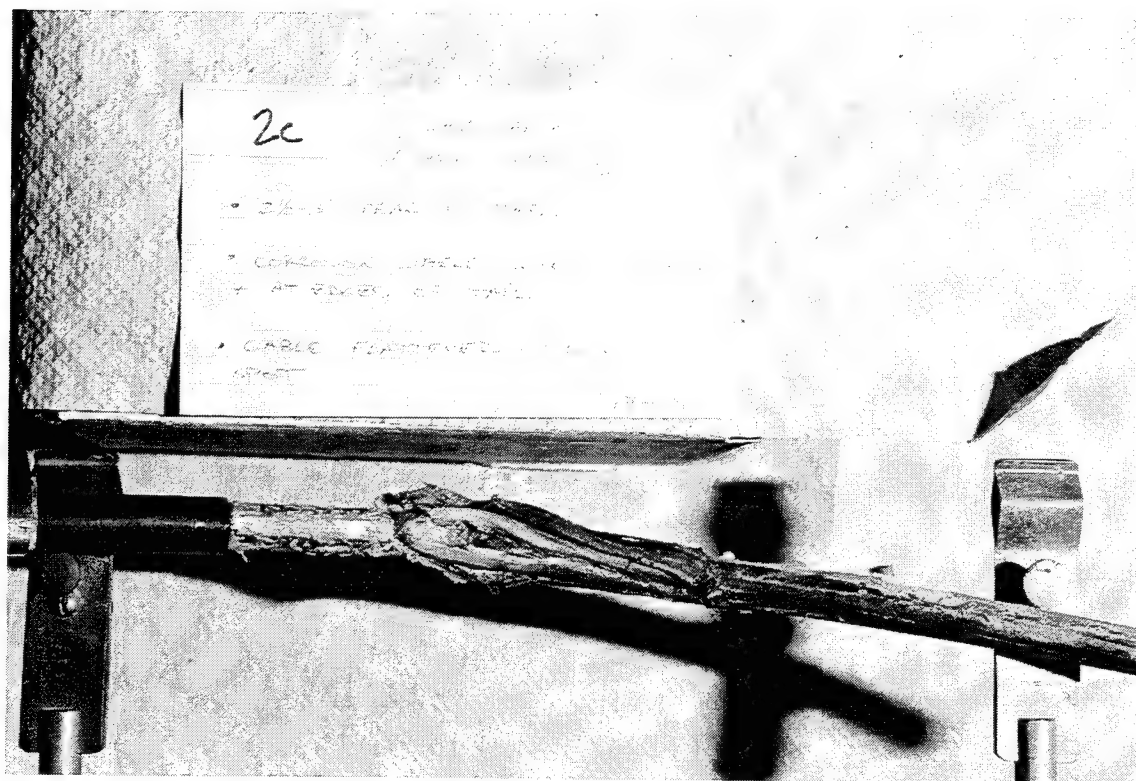
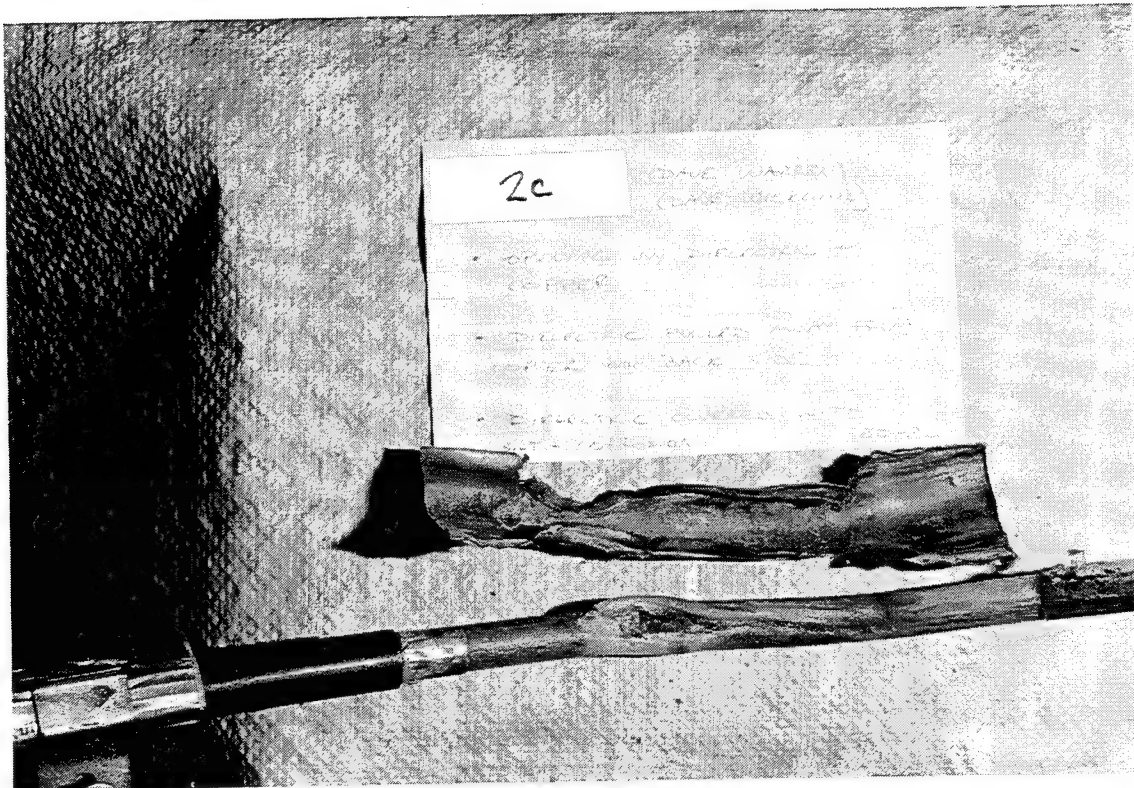
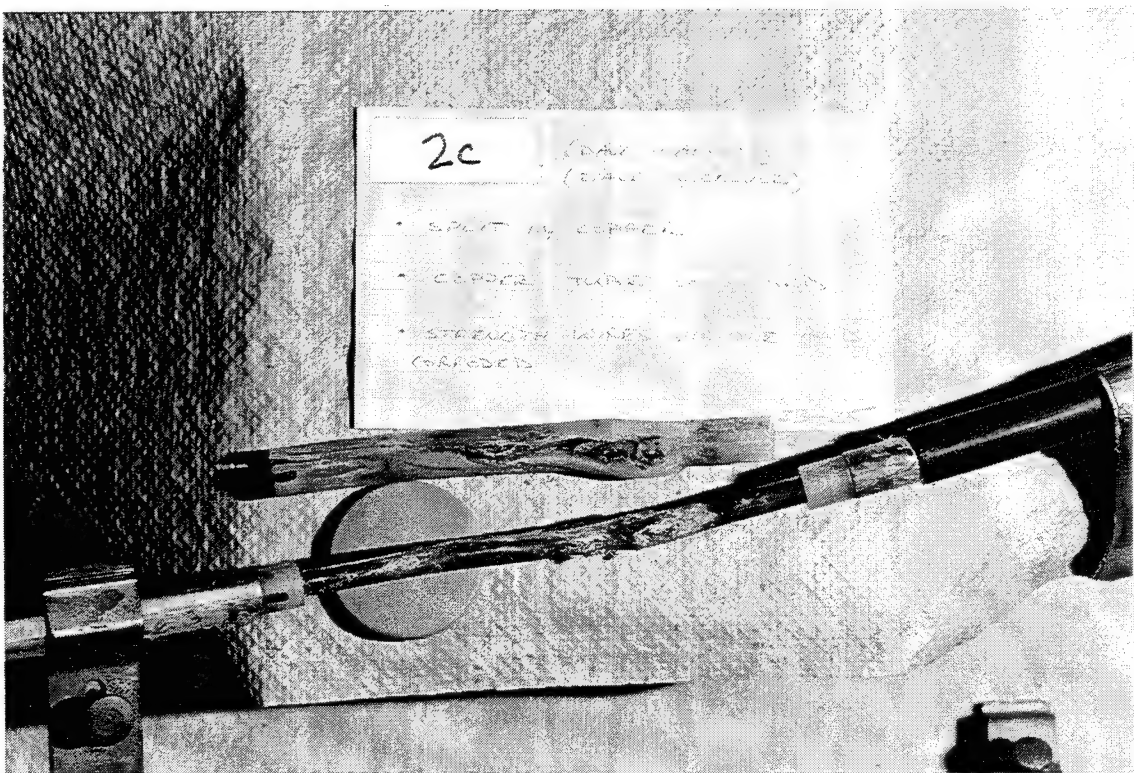
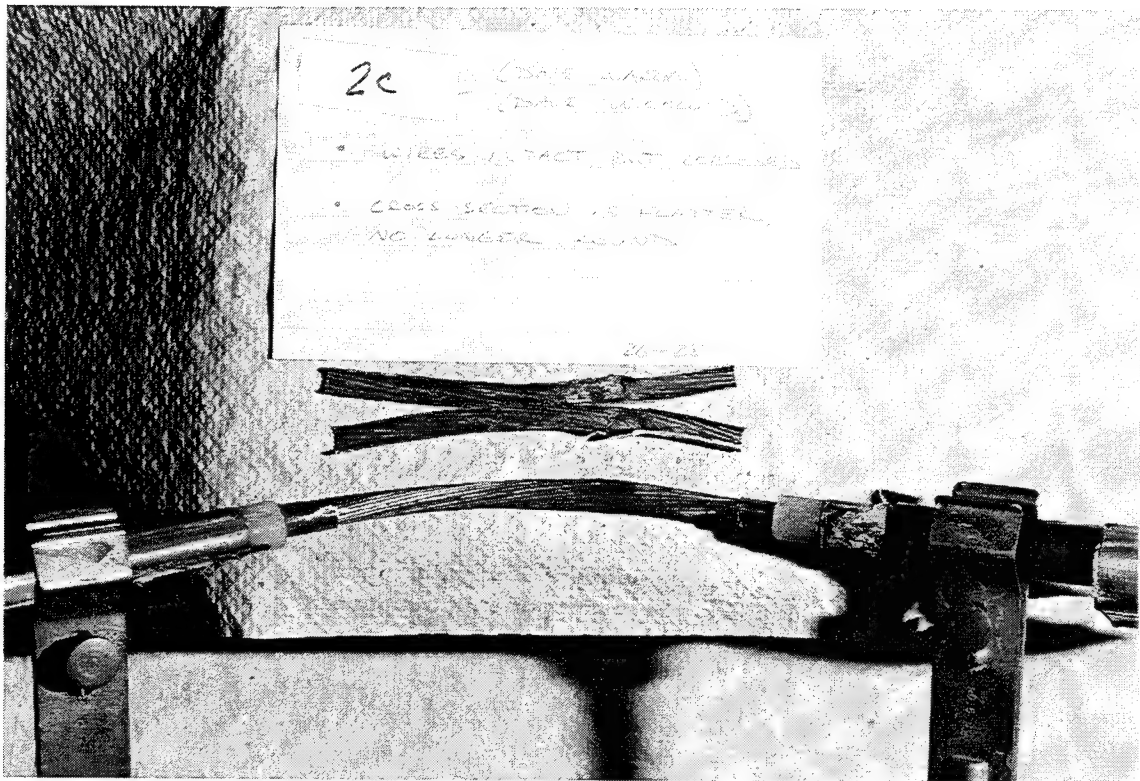
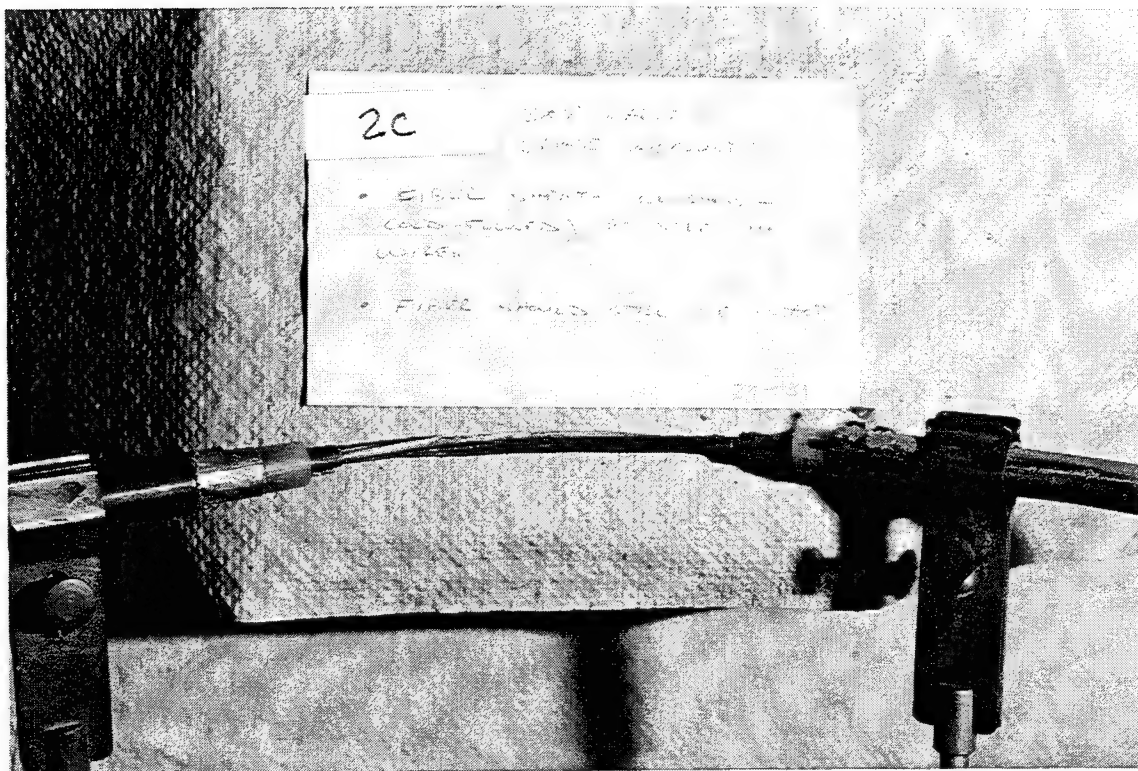
5.4 Fault Number 2c - FDS-D CABLE AUTOPSY WORKSHEET

Condition of Optical Fiber Sheath: The sheath is intact but has been crushed by the strength wires. The nylon jacket and buffer have cold-flowed when crushed by the inner layer of wires.

Condition of Fiber: By a visual inspection the fiber appears intact. Power meter tests were not possible.
